Affordable Inspections

1-103 Howe Street Lambton

23rd January 2018

Building Report

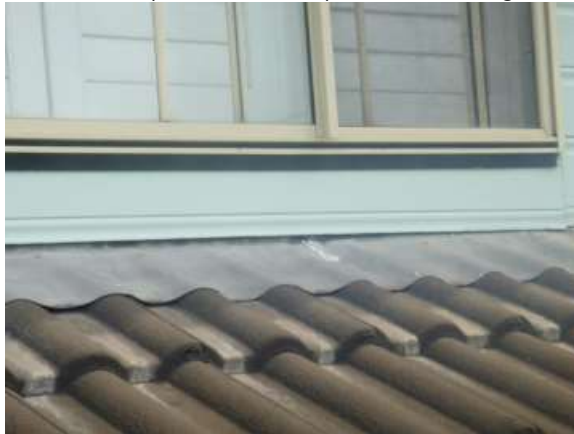
Roof Flashing - Type and Condition: Flashing material is of lead. Flashings appear to be in serviceable condition. It should be noted that flashings are only viewed from a distance in some areas and sometimes defects are very small and not clearly visible. Flashing is cracked, and will require rectification (some silicone) in the following areas: Front elevation.

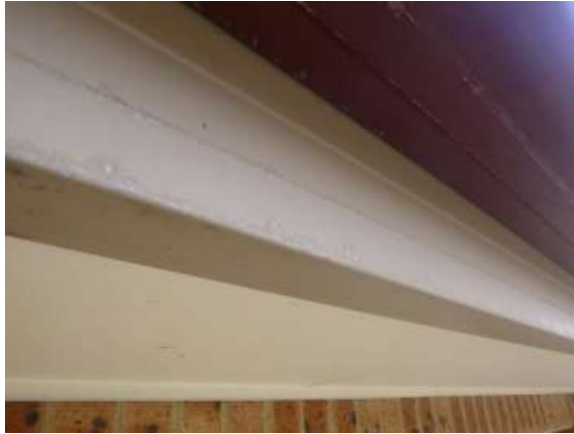
Fascias & Bargeboards The overall condition of the fascias/bargeboards is good. Minor corrosion was noted to some fascia boards.
Type & Condition:

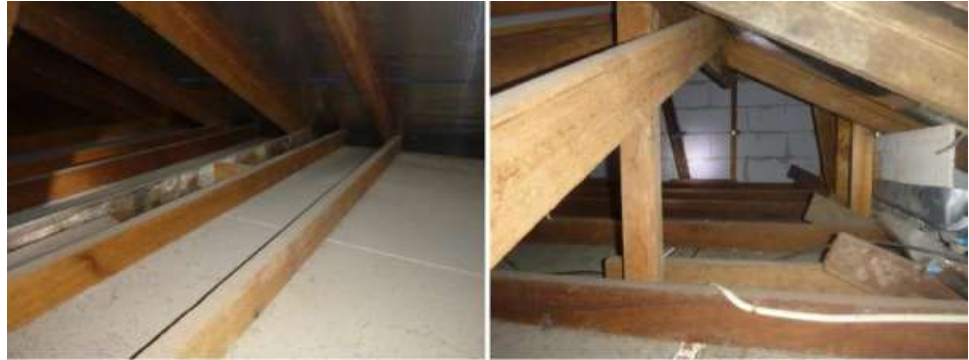
- Roof Supports - Type and Condition:** The cut and pitched roof timbers appear to provide adequate support.

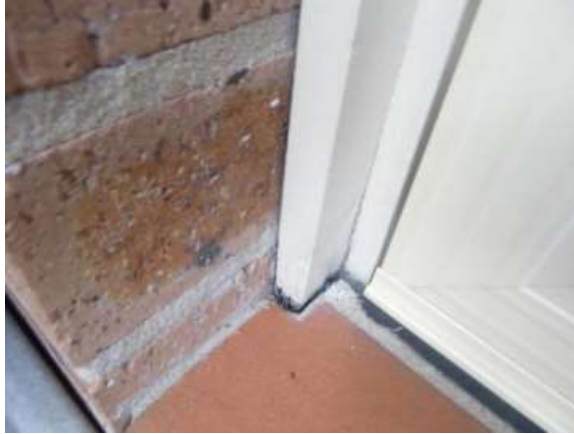
The condition of the walls is generally good. Some decay was noted to trims around rear door.

A licensed builder should be called to make a further evaluation and repairs or rectification as needed.

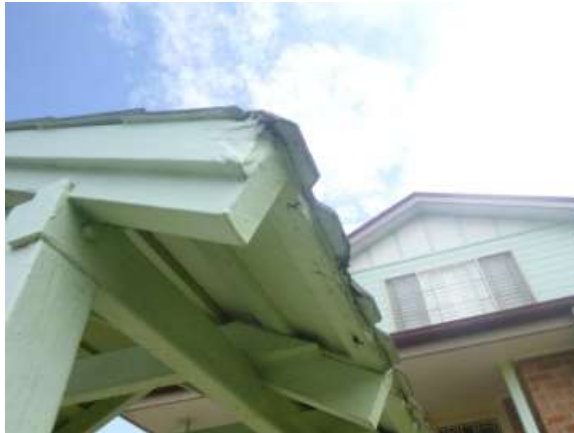
Position/Location:	Front elevation.
Construction & Condition:	Constructed from timber. The general condition of this structure is fair.
Defects or Maintenance Items:	Moderate wood decay is present to the structure. Some repairs or maintenance will be required.

The following action is recommended: A licensed builder should be called to make a further evaluation and repairs or rectification as needed.

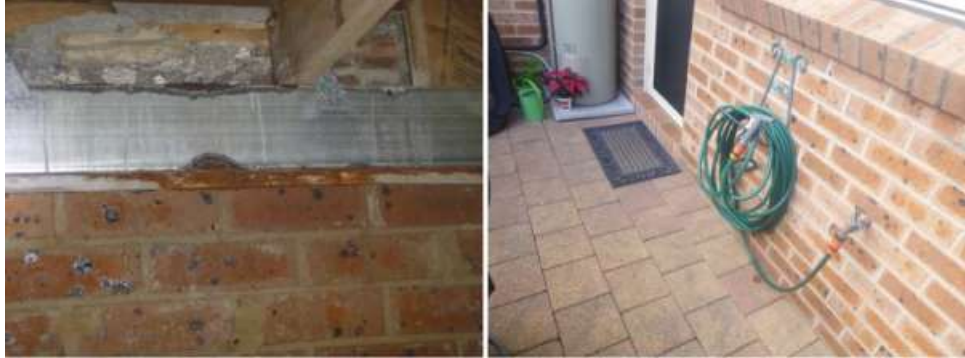
Metal bearers and hyspan joists. Some rust was noted to rear beaver from seepage from rear paved area, this will require rectifying.

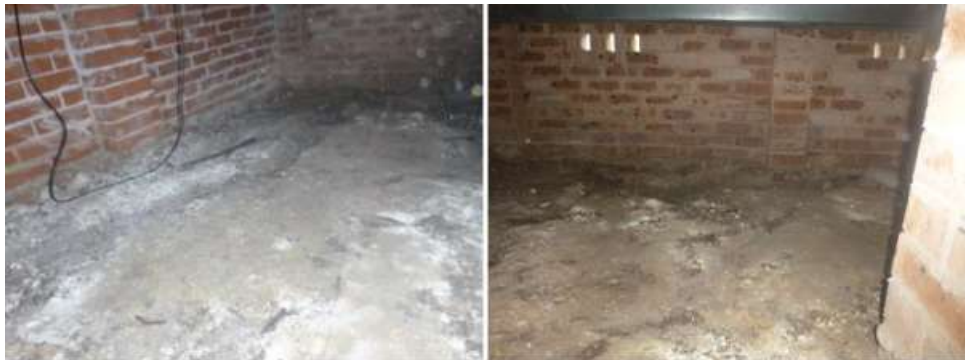
Minor seepage was noted to subfloor area.

A licensed builder should be called to make a further evaluation and repairs or rectification as needed. A Licensed plumber should be called to make a further evaluation and repairs or rectification as needed.
