Affordable Inspections

1-103 Howe Street Lambton

23rd January 2018

Building Report

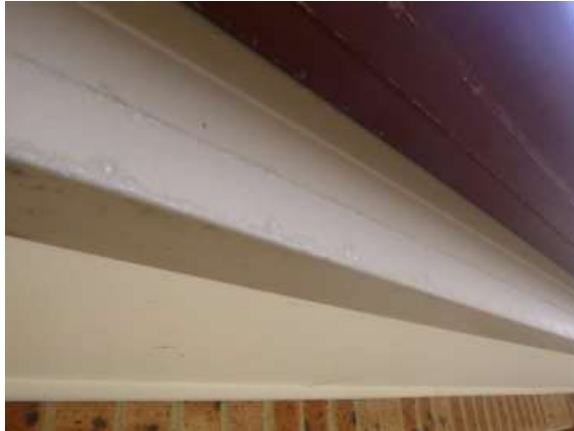
Fascias & Bargeboards The overall condition of the fascias/bargeboards is good. Minor corrosion was noted to some fascia boards.
Type & Condition:

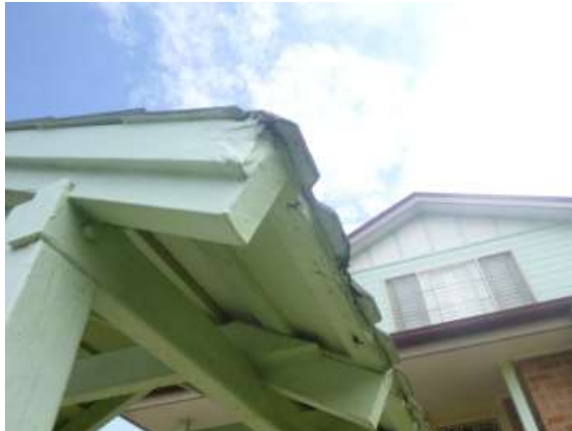
Position/Location: Front elevation.
Construction & Condition: Constructed from timber. The general condition of this structure is fair.
Defects or Maintenance Items: Moderate wood decay is present to the structure. Some repairs or maintenance will be required.

The following action is recommended: A licensed builder should be called to make a further evaluation and repairs or rectification as needed.

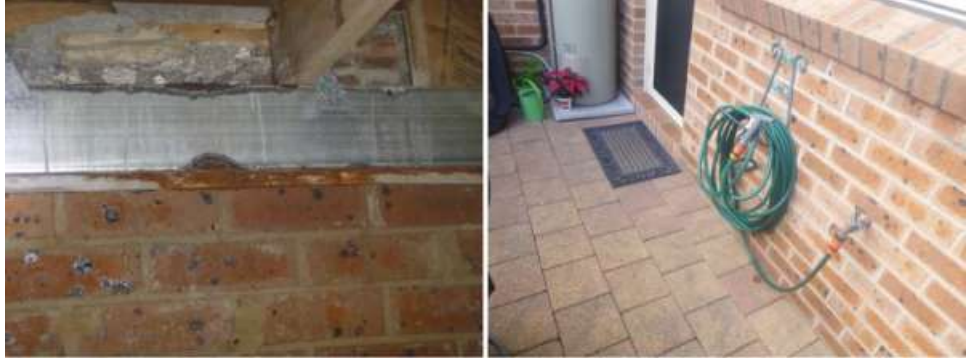
Metal bearers and hyspan joists. Some rust was noted to rear beaver from seepage from rear paved area, this will require rectifying.

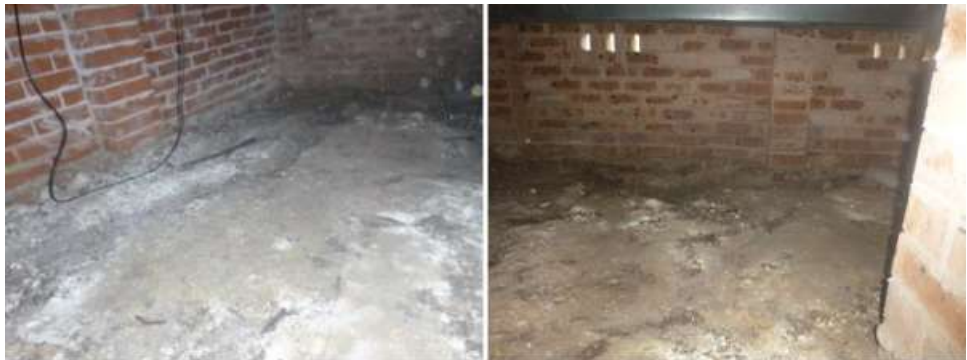
Minor seepage was noted to subfloor area.

A licensed builder should be called to make a further evaluation and repairs or rectification as needed. A Licensed plumber should be called to make a further evaluation and repairs or rectification as needed.
