# Affordable Inspections

55 Sparke Street Georgetown

12th December 2017

## **Building Report**

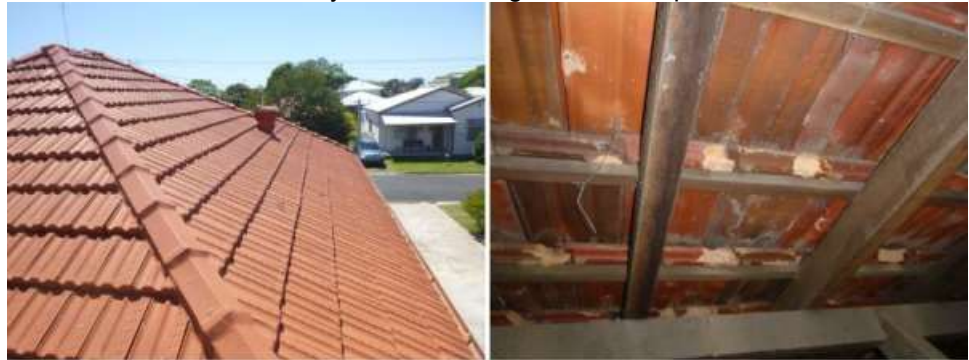
Eyelets on roof used to support tall ariels require sealing or removing to avoid any possible leaks in the future. Major tile fretting was noted to terracotta tiles. This will continue to deteriorate and you should budget for their replacement in the short term.

A licensed builder should be called to make a further evaluation and repairs or rectification as needed.

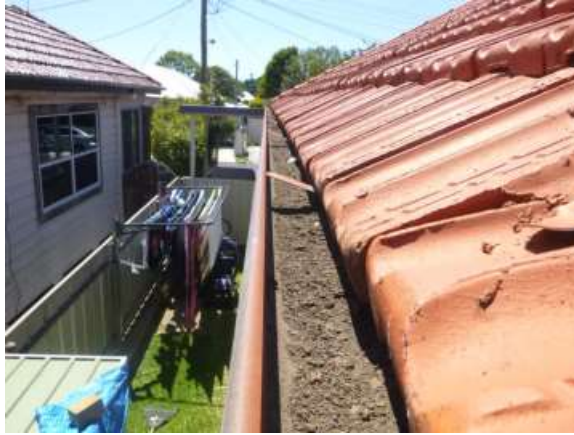
The overall condition of the skillion roof coverings is good.

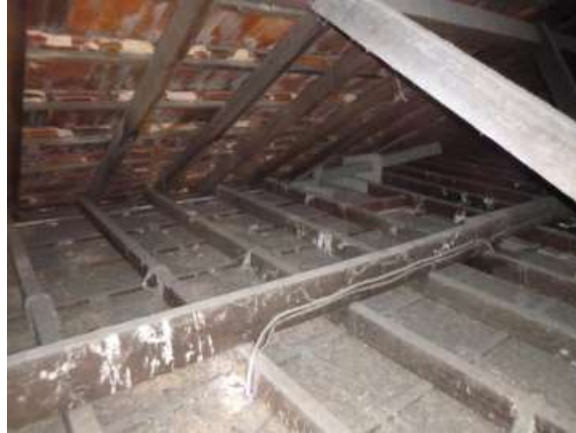
**Roof Supports - Type and Condition:** The cut and pitched roof timbers appear to provide adequate support.

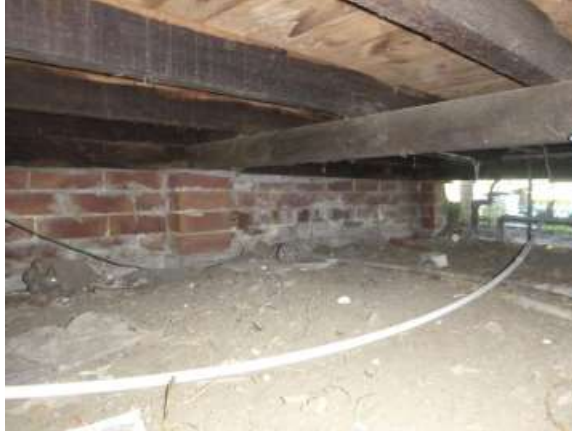
**Flooring:** Timber Flooring construction.  
**Bearers & Joists:** Hardwood bearers and joists.  
**Piers:** Brick Piers. Concrete Piers.
